Roanoke, Town of  
(M.E. Whelan House)  
Roanoke  
Lewis County  
West Virginia

HABS No. WV-209-D

WRITTEN HISTORICAL AND DESCRIPTIVE DATA

ROANOKE, TOWN OF  
(M.E. Whelan House)

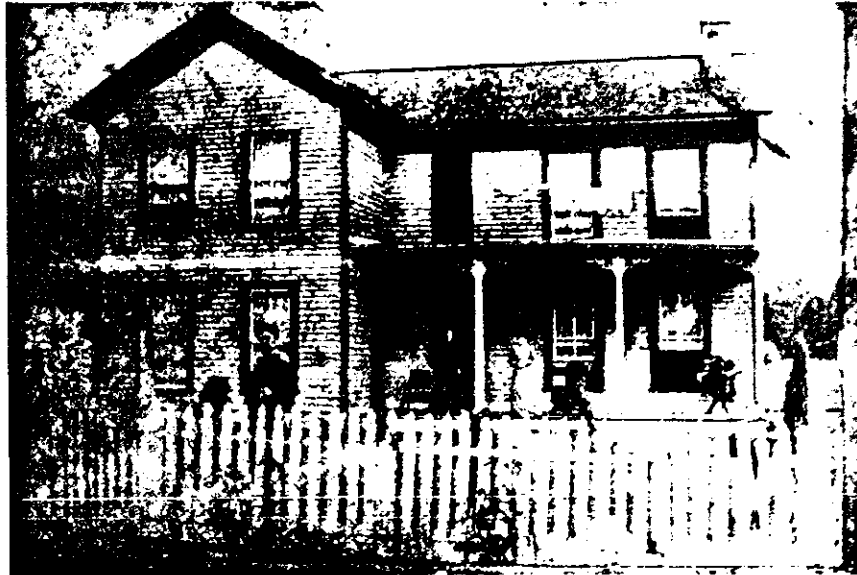
The southeast elevation of the M. E. Whelan dwelling ca. 1885. Dr. Whelan is at left. Others in the photograph are (left to right) Julie and Mary Whelan. Note that the second story porch on the southeast elevation has not yet been built, although a door opening onto the porch roof is visible (James Whelan Photograph Collection).

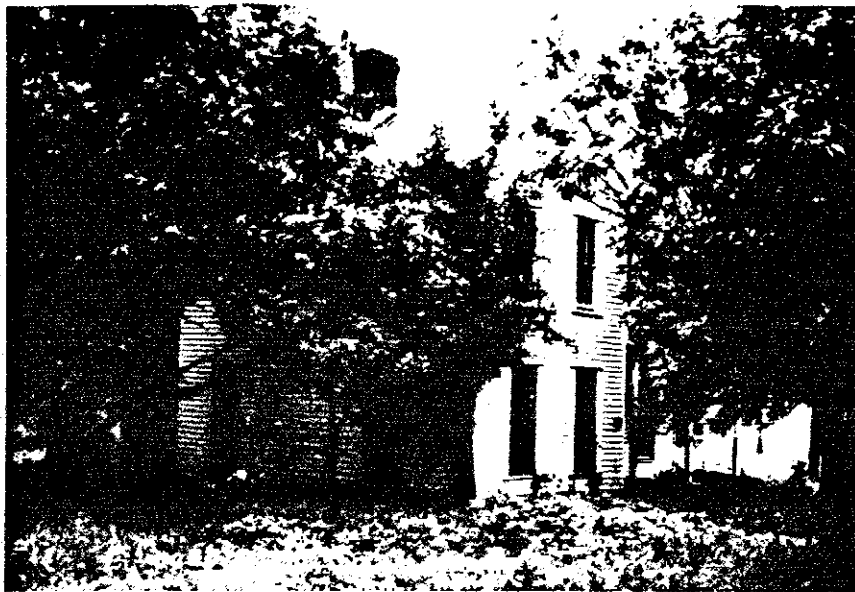
The southeast and southwest elevations of the M. E. Whelan dwelling in 1981. In this photograph one of the brick chimneys is visible.

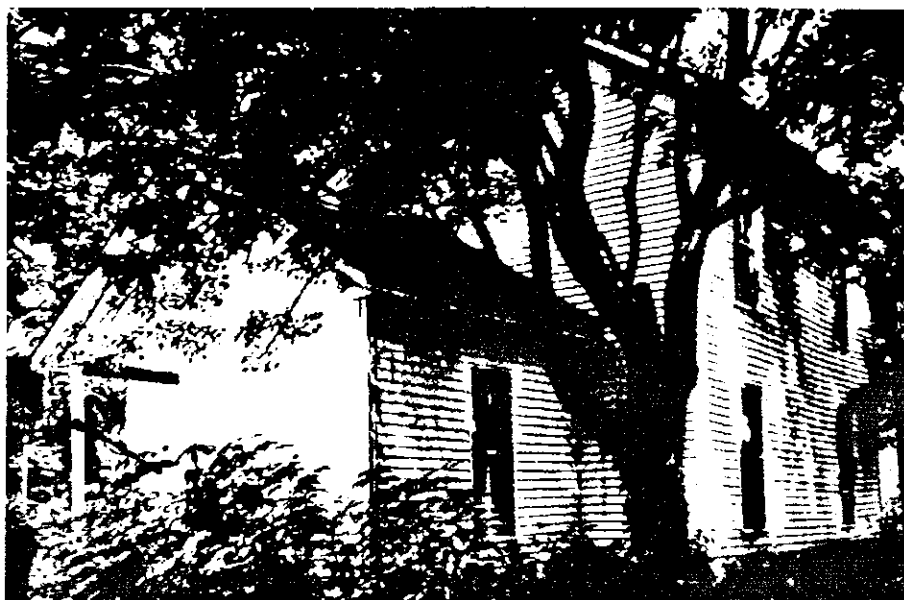
Perspective control photograph of the southwest and northwest elevations of the M. E. Whelan dwelling in 1981. Note the ornamental brackets beneath the soffit.

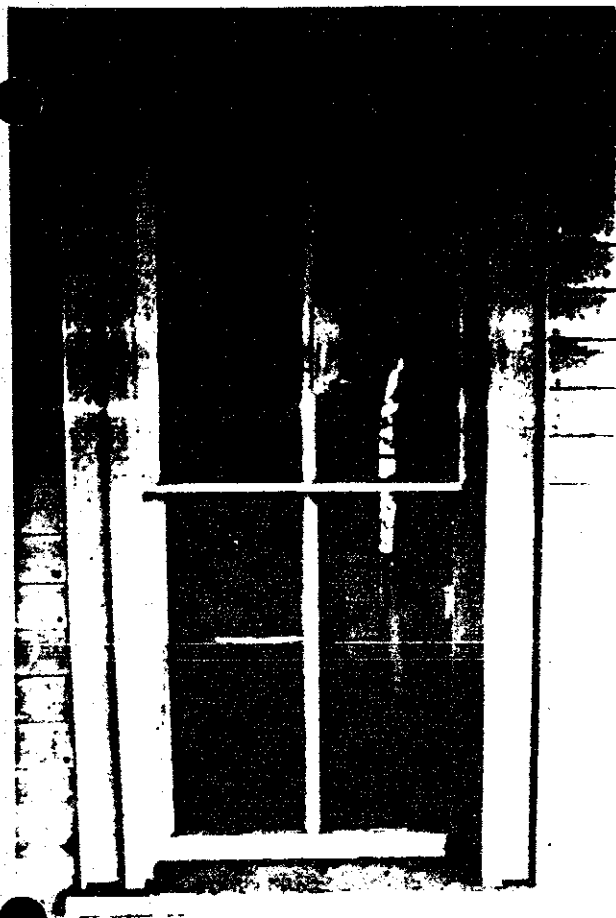
Close-up of a 2/2 light double hung sash window typical of the M. E. Whelan dwelling. Note the exterior surround trim. This window is in the southeast elevation of the structure.

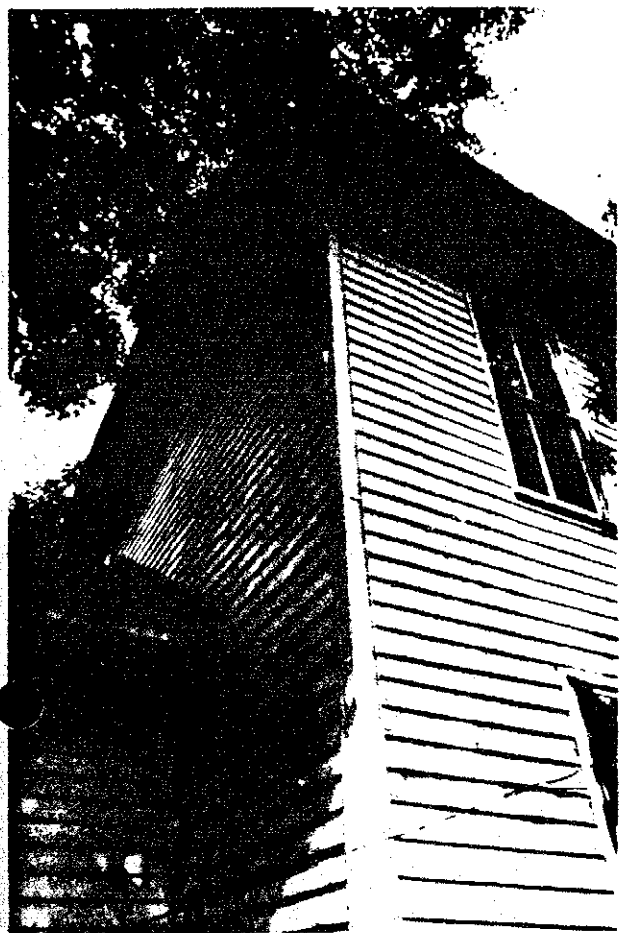
Close-up of the eaves and gable along the southwest elevation of the M. E. Whelan dwelling in 1981. Note the ornamental brackets.

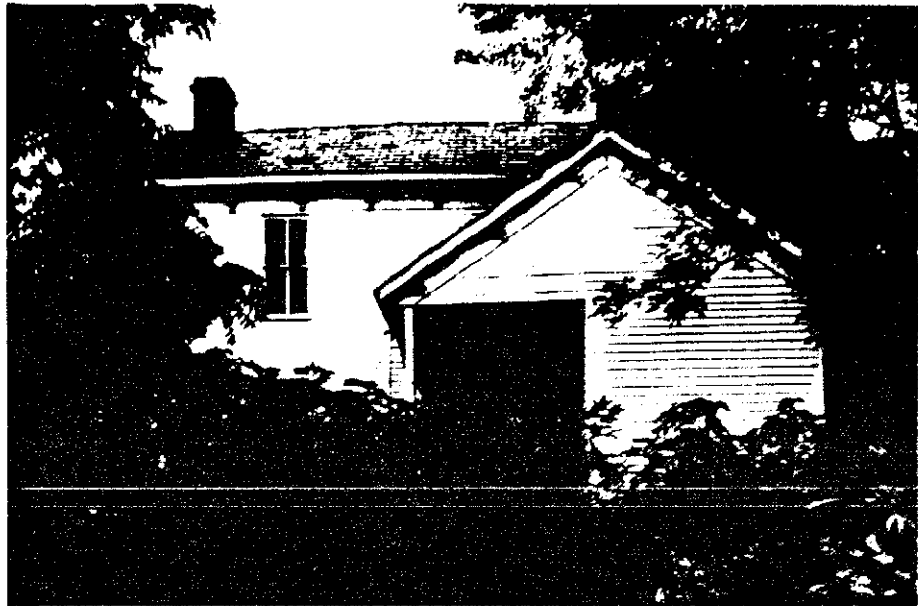
Perspective control photograph of the northwest elevation of the M. E. Whelan dwelling in 1981. Note the northeast-facing porch and the ornamental brackets.

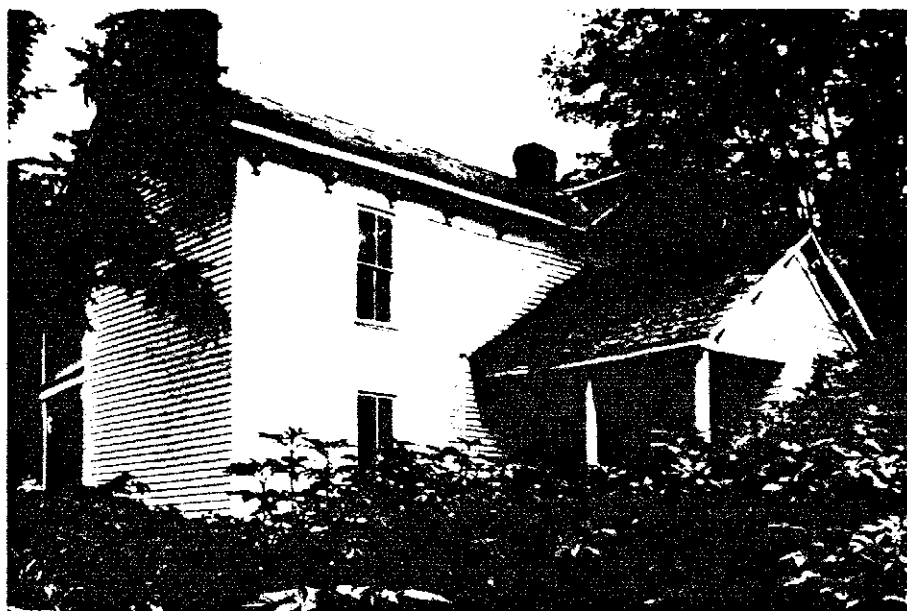
Perspective control photograph of the northwest and northeast elevations of the M. E. Whelan dwelling in 1981. Note the porch attached to the northwest elevation and the brick chimneys.

Chimneys: On the roof peak toward the northeast end of the dwelling there is a sandstone chimney with a brick stack ; on the roof peak near the inside corner of the right angle of the ell there is a sandstone chimney with a brick stack ; on the roof peak at the northwest end of the addition there is a brick chimney and stack for a stove .

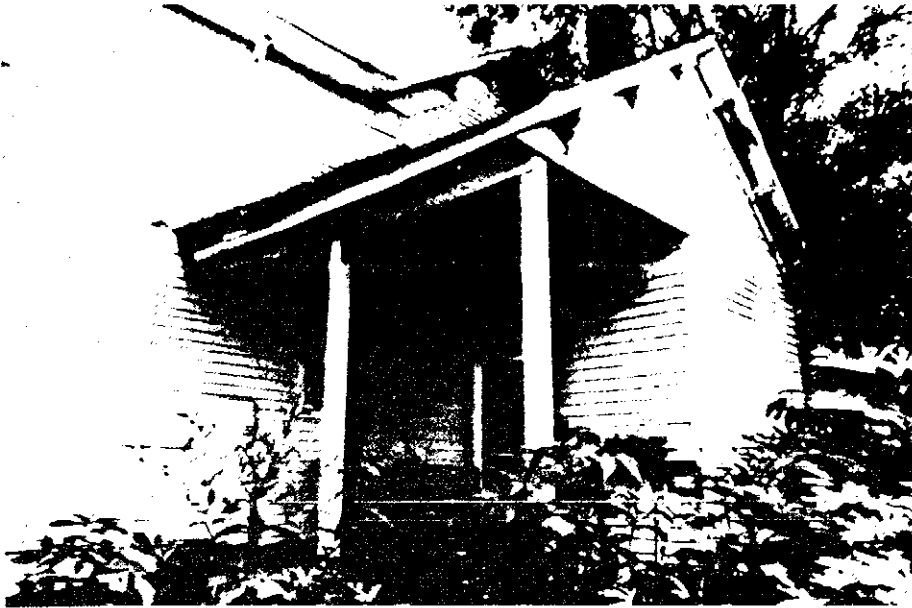
Close-up of porch attached to the northwest elevation of the M. E. Whelan dwelling in 1981. Note the ornamental brackets.

A second porch is attached to the northwest elevation structure. This porch is centered opposite a window (originally a door) which in turn is nearly opposite the front door of the dwelling. On a southeast to northwest axis the porch measures 14'1" and from southwest to northeast, 7'11"; 3 1/2" tongue and groove boards painted gray compose the deck except for a 3/4" addition to the northwest side of the porch which is covered by 6 1/2"-8 1/2" unpainted boards. The deck is 2' above the ground and is supported on a 1 1/4" x 1 1/4" sandstone pier with beveled top edges at the north corner and by a 5" x 5" wooden post along the northeast wall between the sandstone pier and the northwest wall of the dwelling. The slate-covered roof is an extension of the roofline of an earlier rear addition and is supported over the porch by two white-painted 5" x 5" square columns; access to this porch is from the northwest via a 30" wide x 11" tread x 6" rise sandstone step plus a 14" riser.

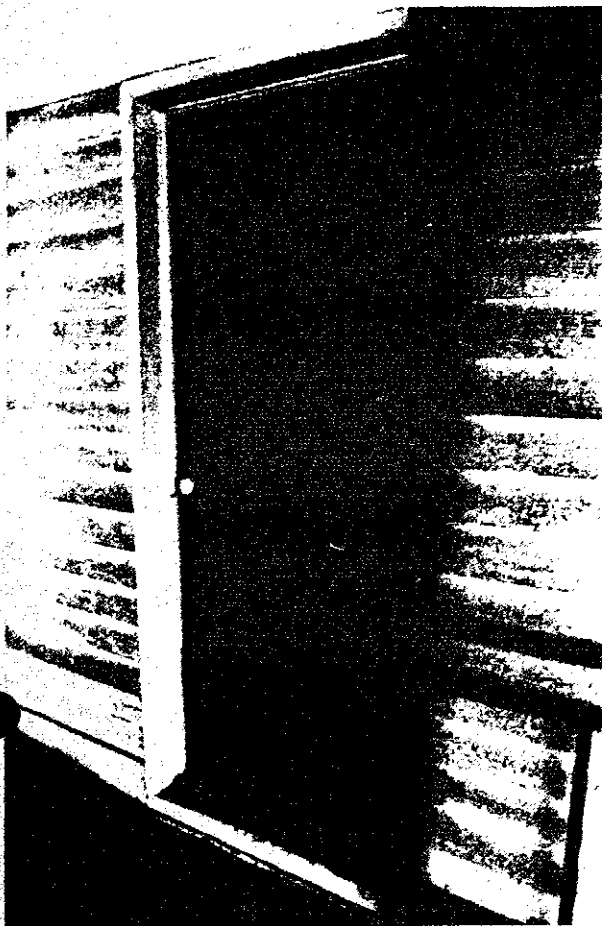
Close-up of Room 5 to exterior door from the porch attached to the northwest elevation of the M. E. Whelan dwelling in 1981.

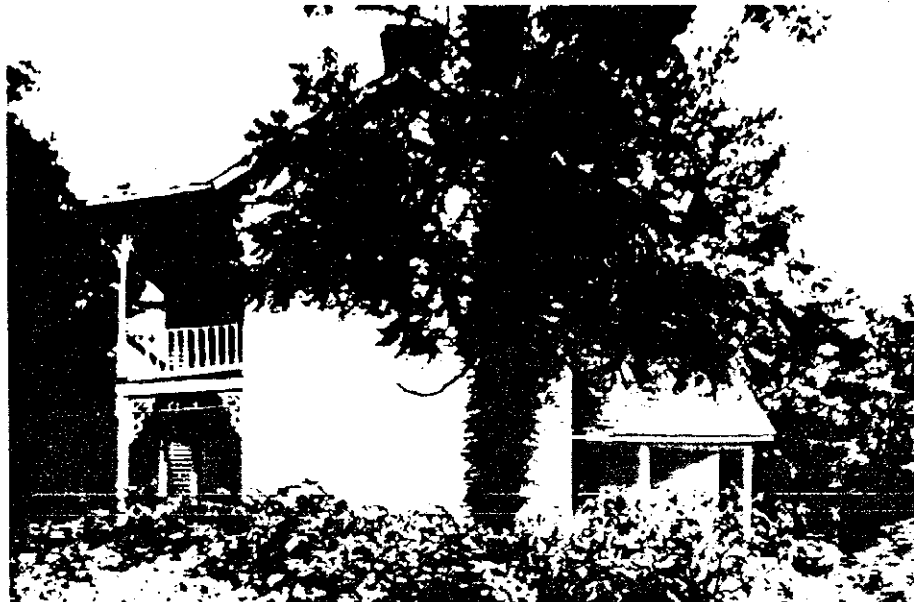
Perspective control photograph of the northeast elevation of the M. E. Whelan dwelling in 1981. Note the porches at both the front and rear of the dwelling.

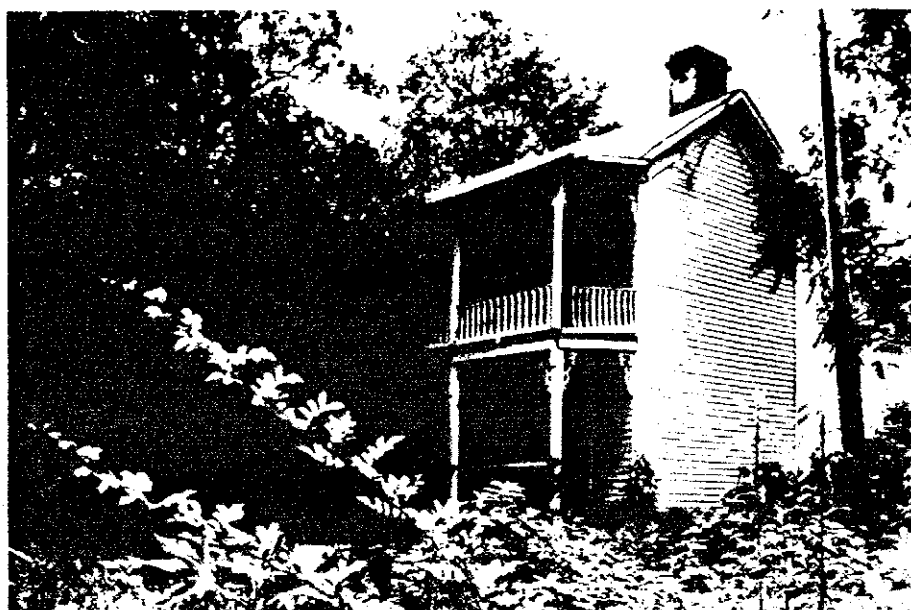
Perspective control photograph of the northeast and southeast elevations of the M. E. Whelan dwelling in 1981. Note the ornate two story porch on the southeast elevation.

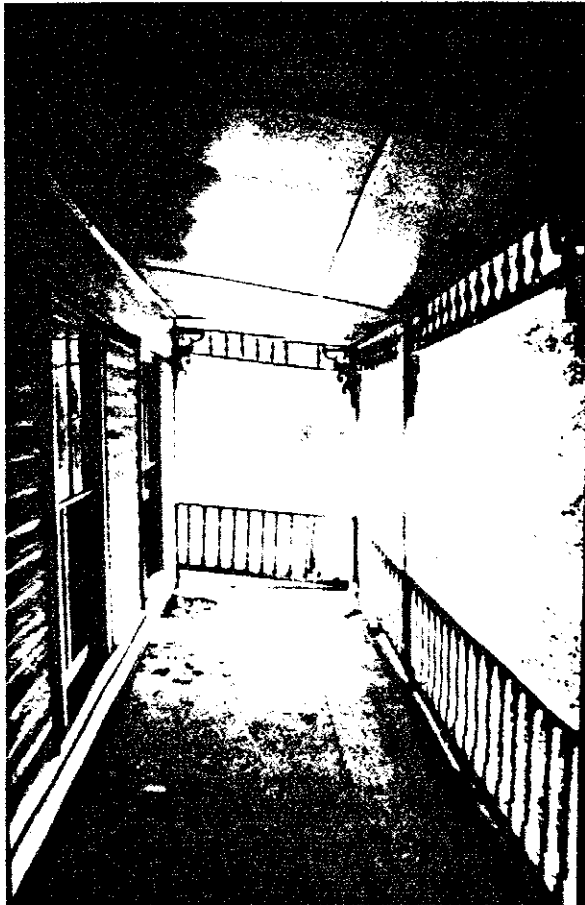
Southwest to northeast view along the second story of the porch attached to the southeast elevation of the M. E. Whelan dwelling in 1981.

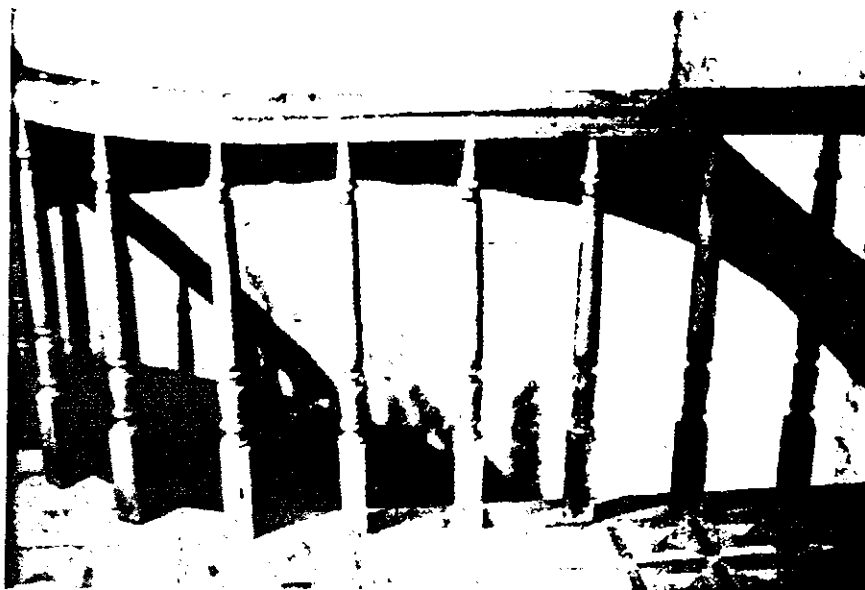
Close-up of balusters and rail in the central staircase of the M. E. Whelan dwelling in 1981.

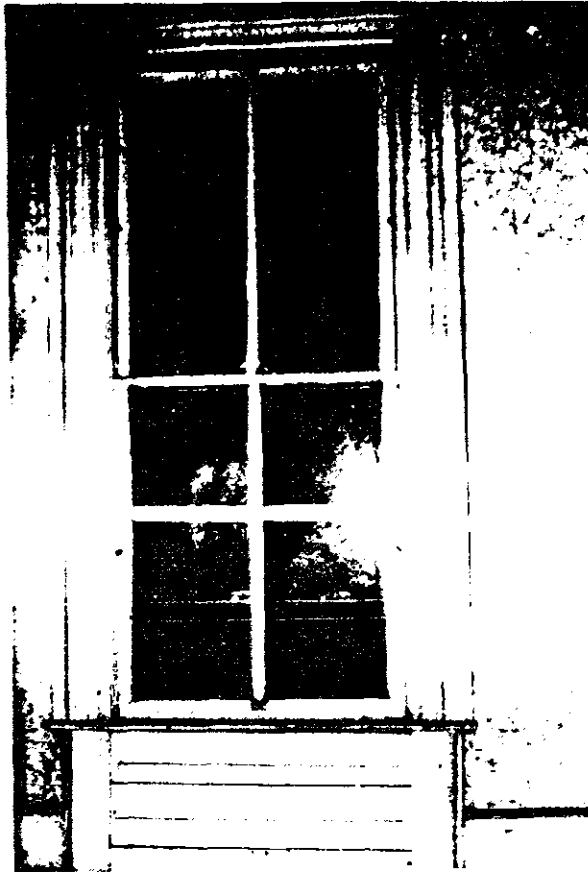
Close-up of 2/2 double hung sash window in the southeastern elevation of Room 1 of the M. E. Whelan dwelling in 1981. Note the interior surround trim.

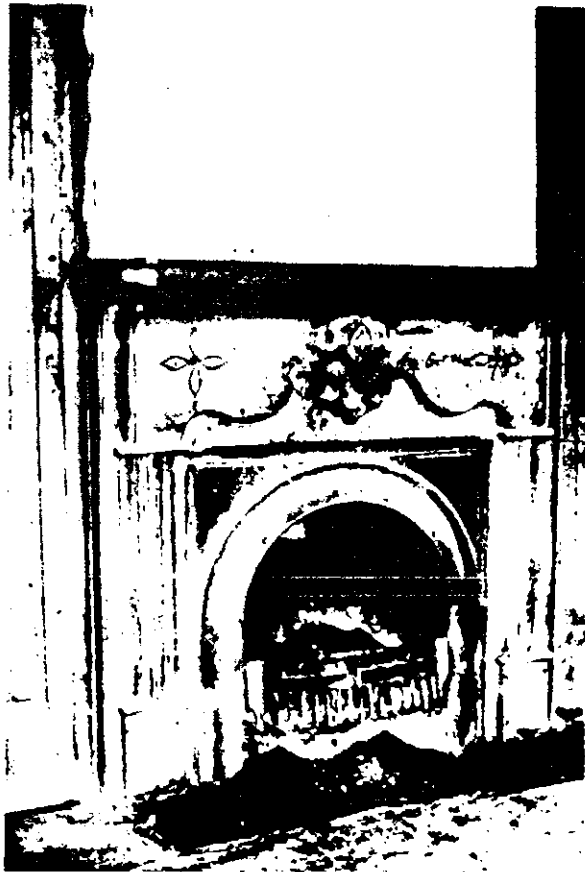
Close-up of ornate mantle  
in Room 3 of the M. E. Whelan dwell-  
ing in 1981.
